Manhole Inspection Summary

Manhole # S59C__003MH

Insp Date: **6/25/08 2:23 PM**

Location Address: **rear 45 n kresson st**

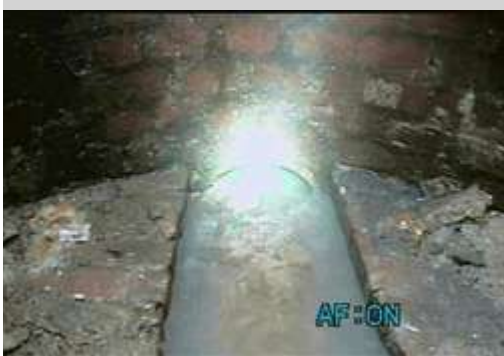
Defect 3

Condition: ☐ Sound ☐ Cracked ☐ Root Intrusion ☐ Deteriorated ☐ Leaks ☒ **Debris**

Channel and bench debris

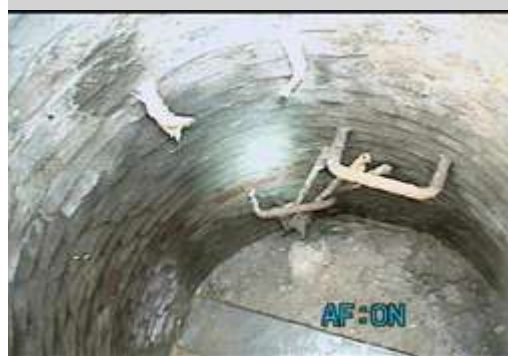
Defect 2

Count: **4** Missing: **2** ☒ **Corroded**

steps

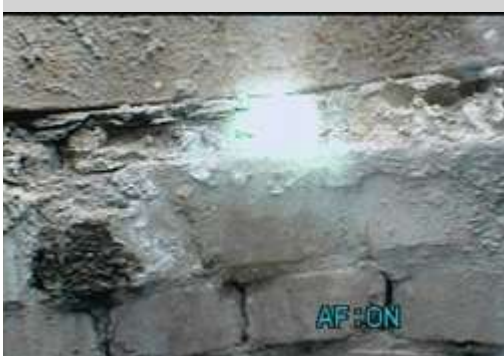
Defect 1

Condition: ☐ Sound ☐ Cracked ☐ Root Intrusion ☐ Loose Brick ☒ **Deteriorated**

Infiltration: ☐ None ☐ Joint ☐ Cracks ☒ **Mortar** ☐ Roots ☐ Wall

deteriorated chimney & infiltration

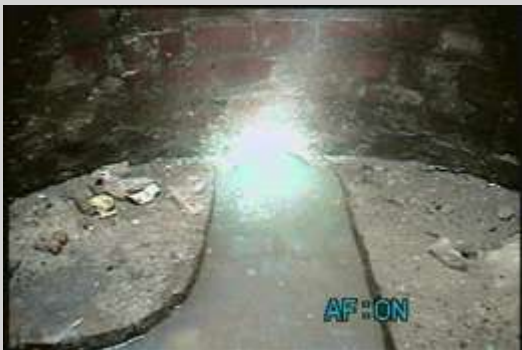
12 O'Clock Outflow

8 in. Circular Gravity Sewer
Pipe Out @ 12 O'Clock

Pipe Material: **Clay** ☐ Pipe Lined

Invert Depth: **8.01** (ft.) Flow Characteristics: **Slow**

Deposits: ☒ None ☐ Mud ☐ Sludge ☐ Debris ☐ Grease

Infiltration: **None** Pipe Seal Cond: **Unknown**

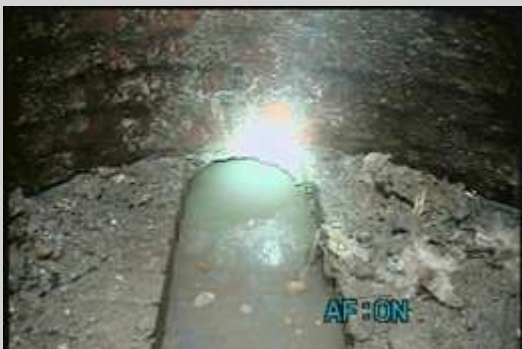
3 O'Clock Inflow

8 in. Circular Gravity Sewer
Pipe In @ 3 O'Clock

Pipe Material: **Clay** ☐ Pipe Lined

Invert Depth: **7.95** (ft.) Flow Characteristics: **Slow**

Deposits: ☒ None ☐ Mud ☐ Sludge ☐ Debris ☐ Grease

Infiltration: **None** Pipe Seal Cond: **Unknown**

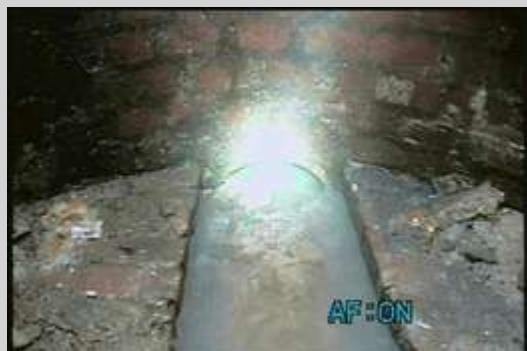
6 O'Clock Inflow

8 in. Circular Gravity Sewer
Pipe In @ 6 O'Clock

Pipe Material: **Clay** ☐ Pipe Lined

Invert Depth: **8.00** (ft.) Flow Characteristics: **Slow**

Deposits: ☒ None ☐ Mud ☐ Sludge ☐ Debris ☐ Grease

Infiltration: **None** Pipe Seal Cond: **Unknown**
